Report on Fractured Leg Brace

Kenneth C. Russell

Department of Materials Science and Engineering

June 13, 1977

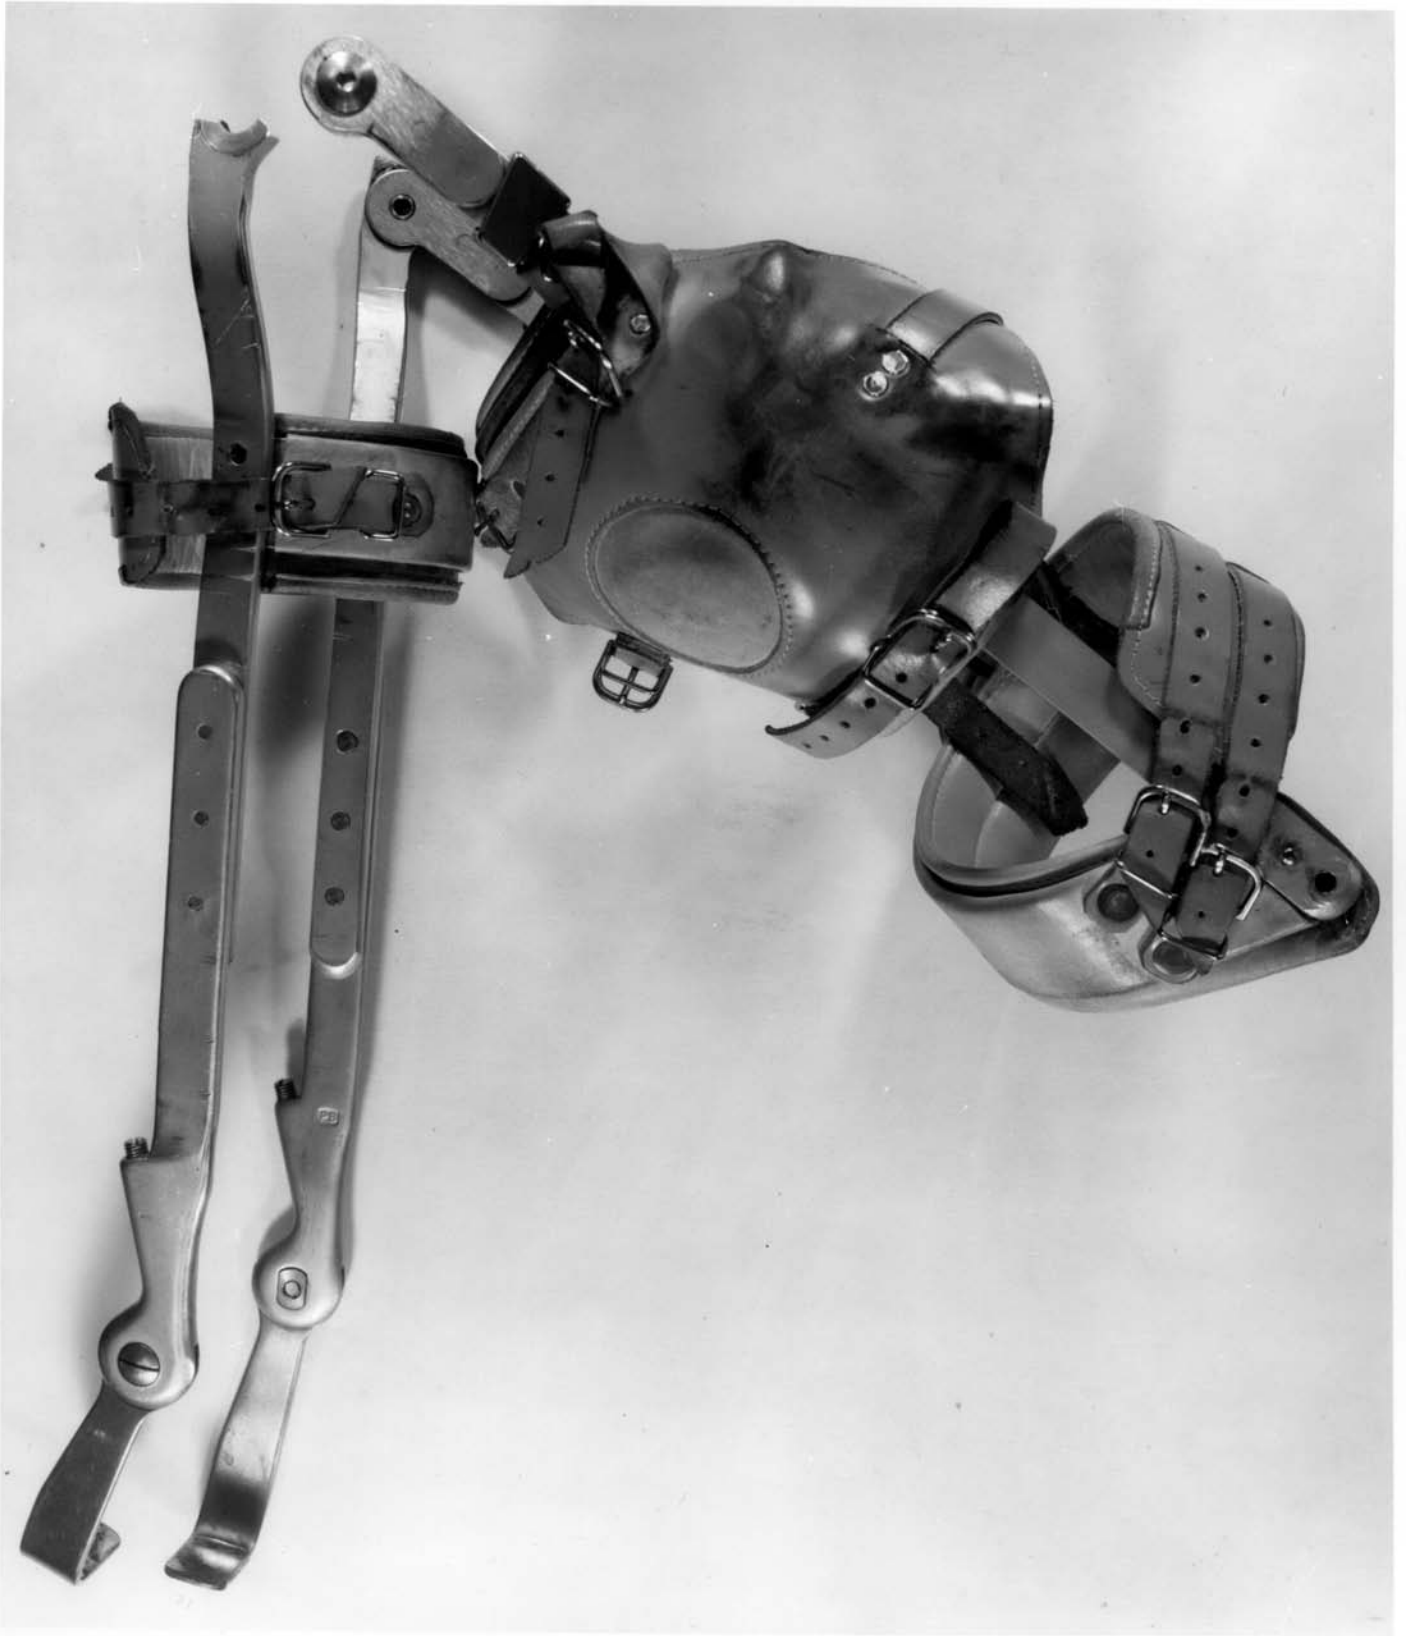
Both the upper and lower members show markings and grooves on the broad faces (some are visible in Figure 1). These would most probably be caused by gripping the member in a bare metal vise to hold the brace while bending it or making other adjustments. Three leather straps seen in Figure 1 are riveted to the brace. This was done in a very amateurish manner, as the surrounding aluminum was battered at the time the rivets were tightened. However, these defects were all on the broad sides of the brace members, which are not a critical stress area.

Figure 1: Failed brace, showing fractured member at upper left.

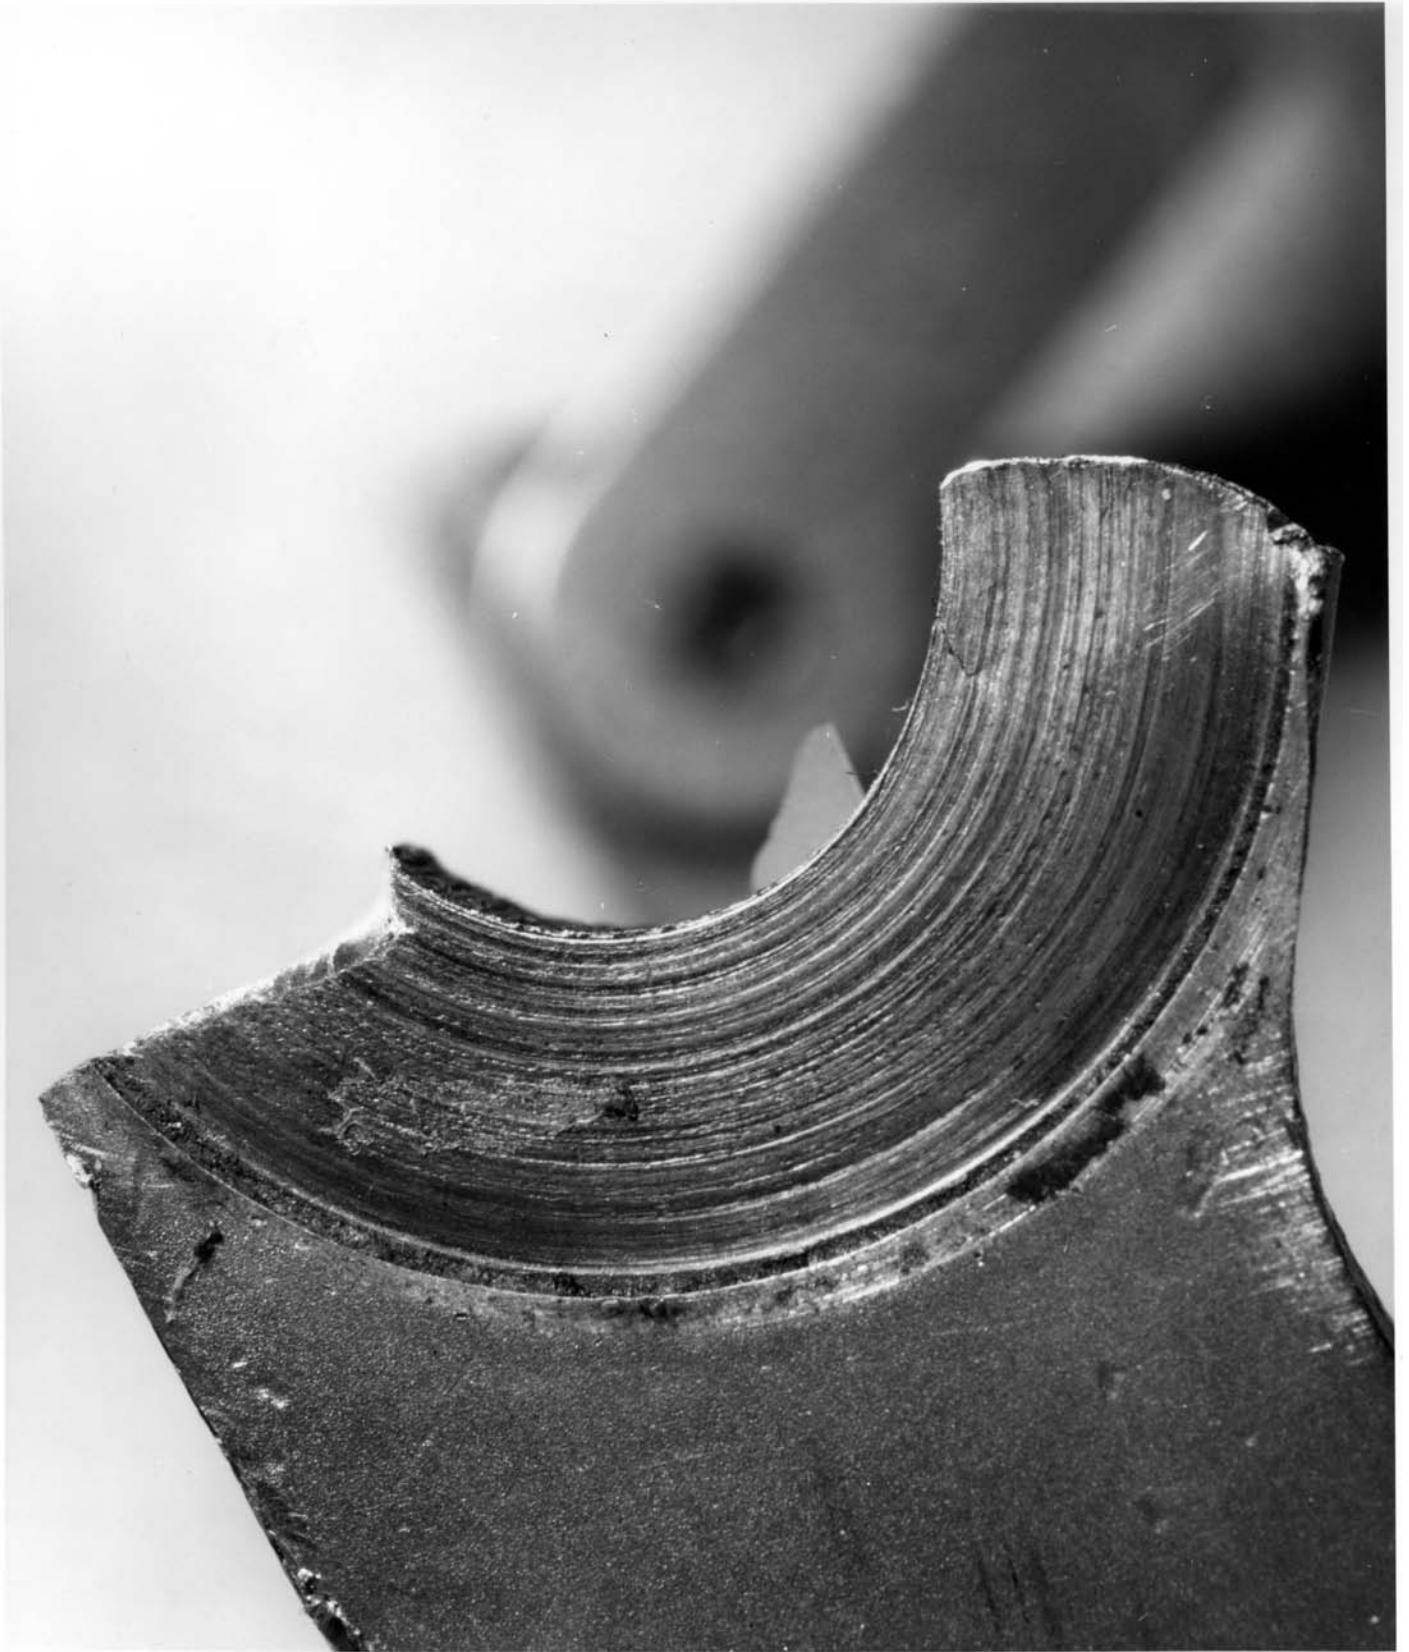
Figure 2: Close-up of side of brace in region of fracture.

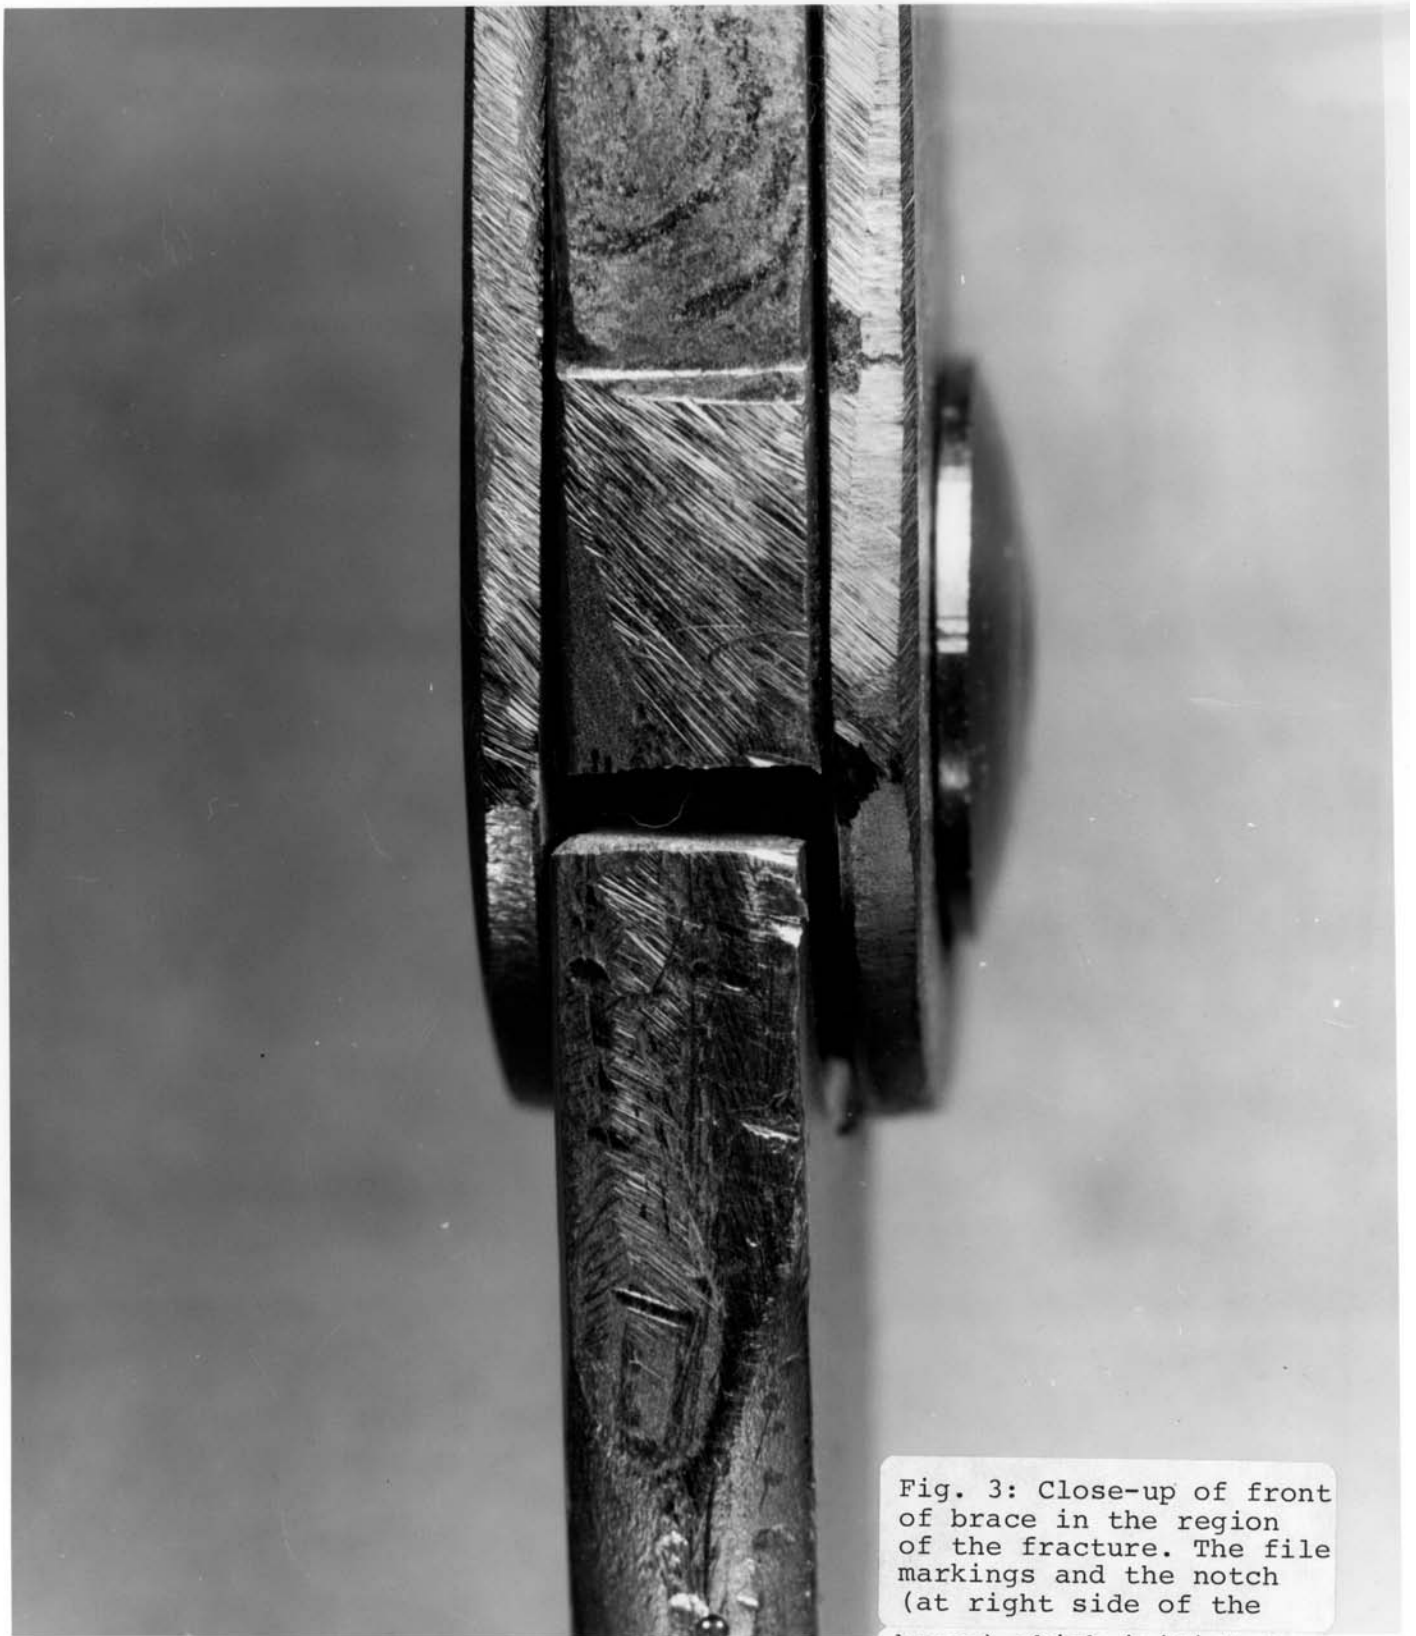
Such notches are known to initiate fatigue cracks and greatly accelerate fatigue failure. The notch could not have been at a worse place or in a worse orientation. The front surface of the member would be in tension, when walking, the tensile stress is a maximum at this point, and the notch is oriented correctly to imitate a fatigue crack. Good engineering and manufacturing practice requires that such notches be avoided in structures subject to cyclic (fatigue) loading.

The real damage was done by whomever introduced the notches in the front edge of the failed member. This region (Figure 3) shows signs of having been filed (perhaps to allow the slip lock to slide down a little further). There are a number of notches, roughly parallel to the ground, on the front edge. (One of these initiated the fatigue crack.) These were caused by striking or rubbing the member with a sharp, hard object. It is quite possible that after the edge was filed, it was struck several times by the edge of the file. However the notches were introduced, they had the effect of sharply reducing the useful life of the brace.

Figure 3: Close-up of front of brace in the region of the fracture. The file markings and the notch (at right side of the brace) which initiated the failure are clearly marked.

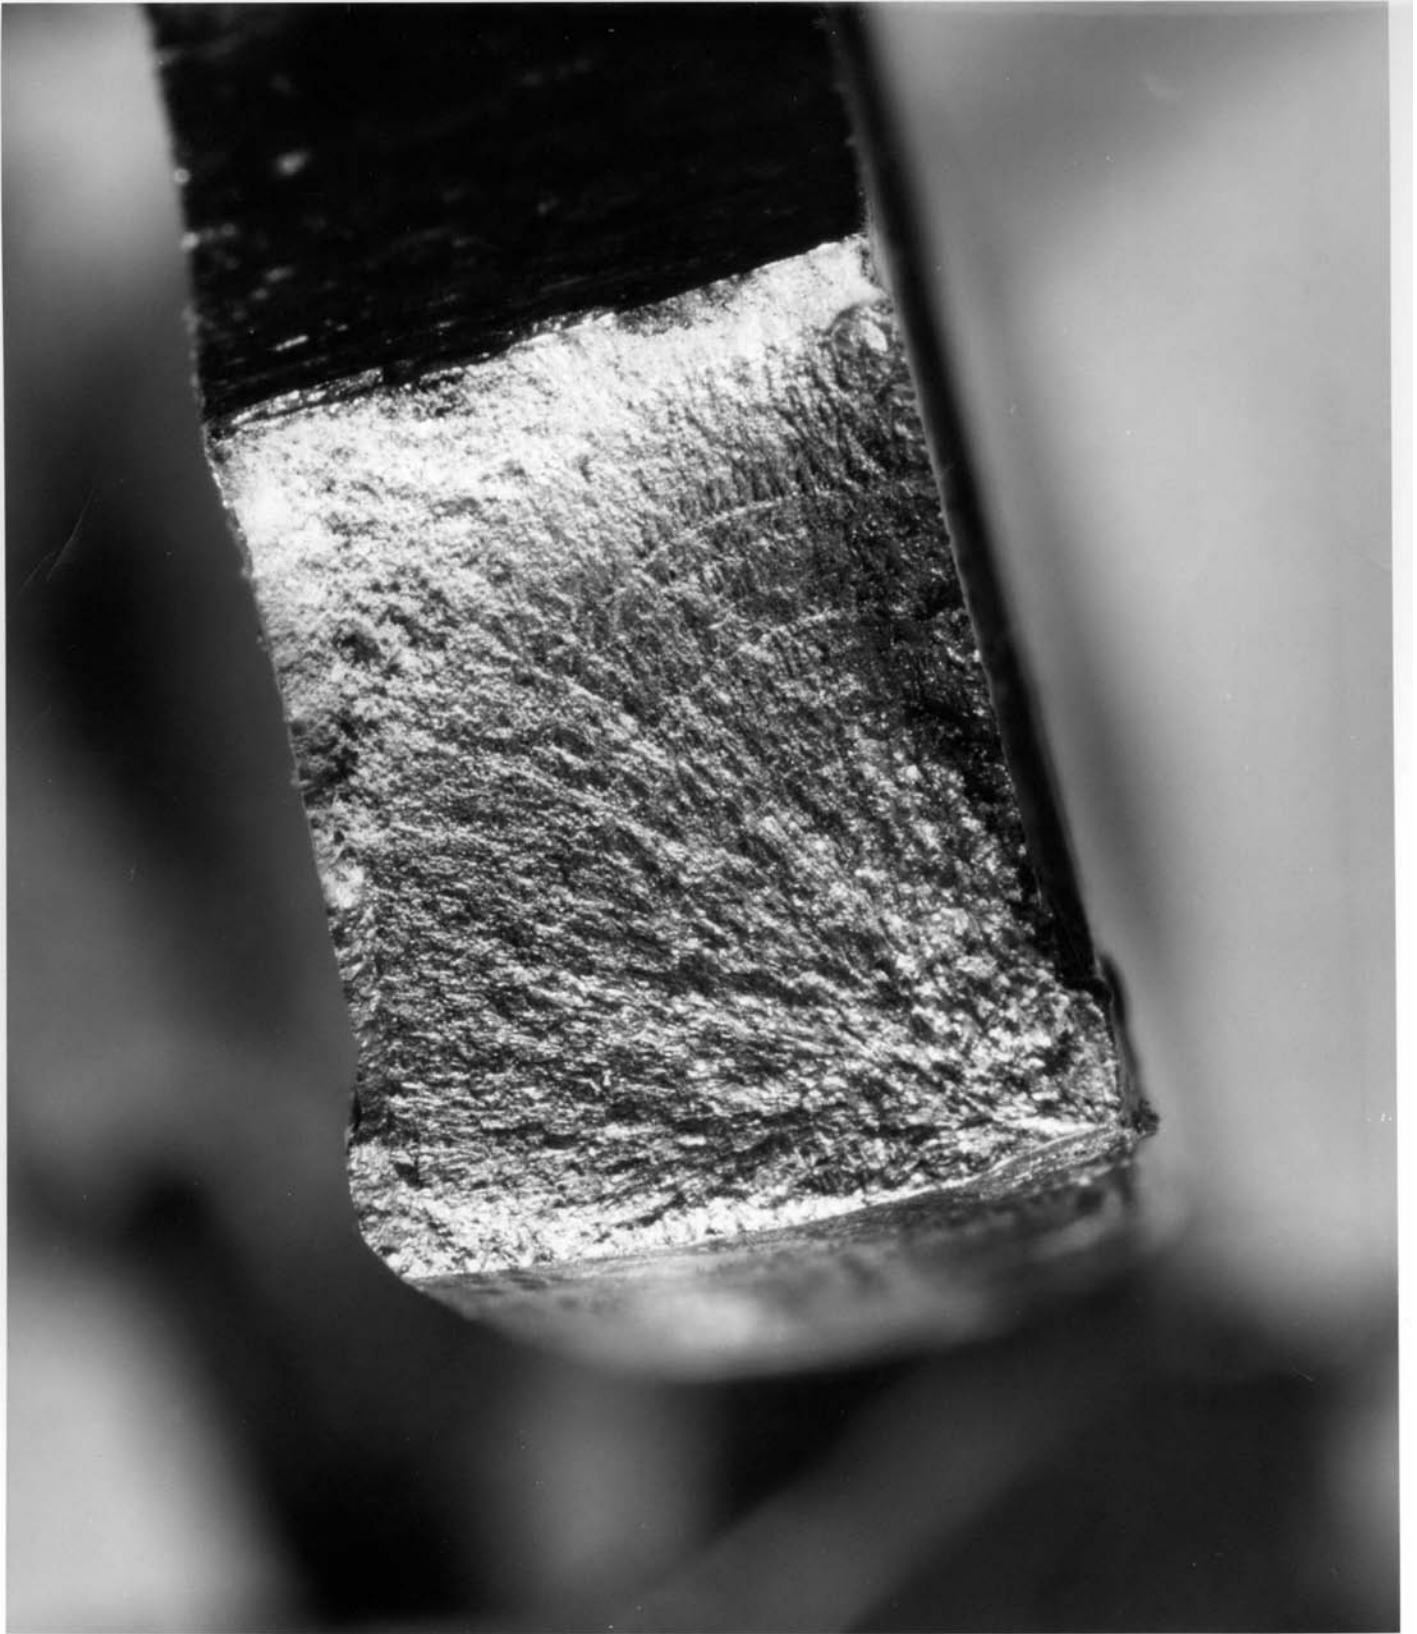
Figure 4 is a close-up of the fracture surface to the left in Figure 2. The circular striations show that the fracture is definitely of the fatigue type. These striations encircle the origin of the fracture (like ripples around a pebble dropped in a lake) which is a notch, at the lower right hand corner (as seen in Figure 4). Examination of the front edge of the brace revealed a number of such notches (see Figure 3), which were apparently introduced by filing.

Figure 4: Close-up of fracture.
