Report on Fractured Eyebolt

Kenneth C. Russell

Department of Materials Science and Engineering

December 1, 1980

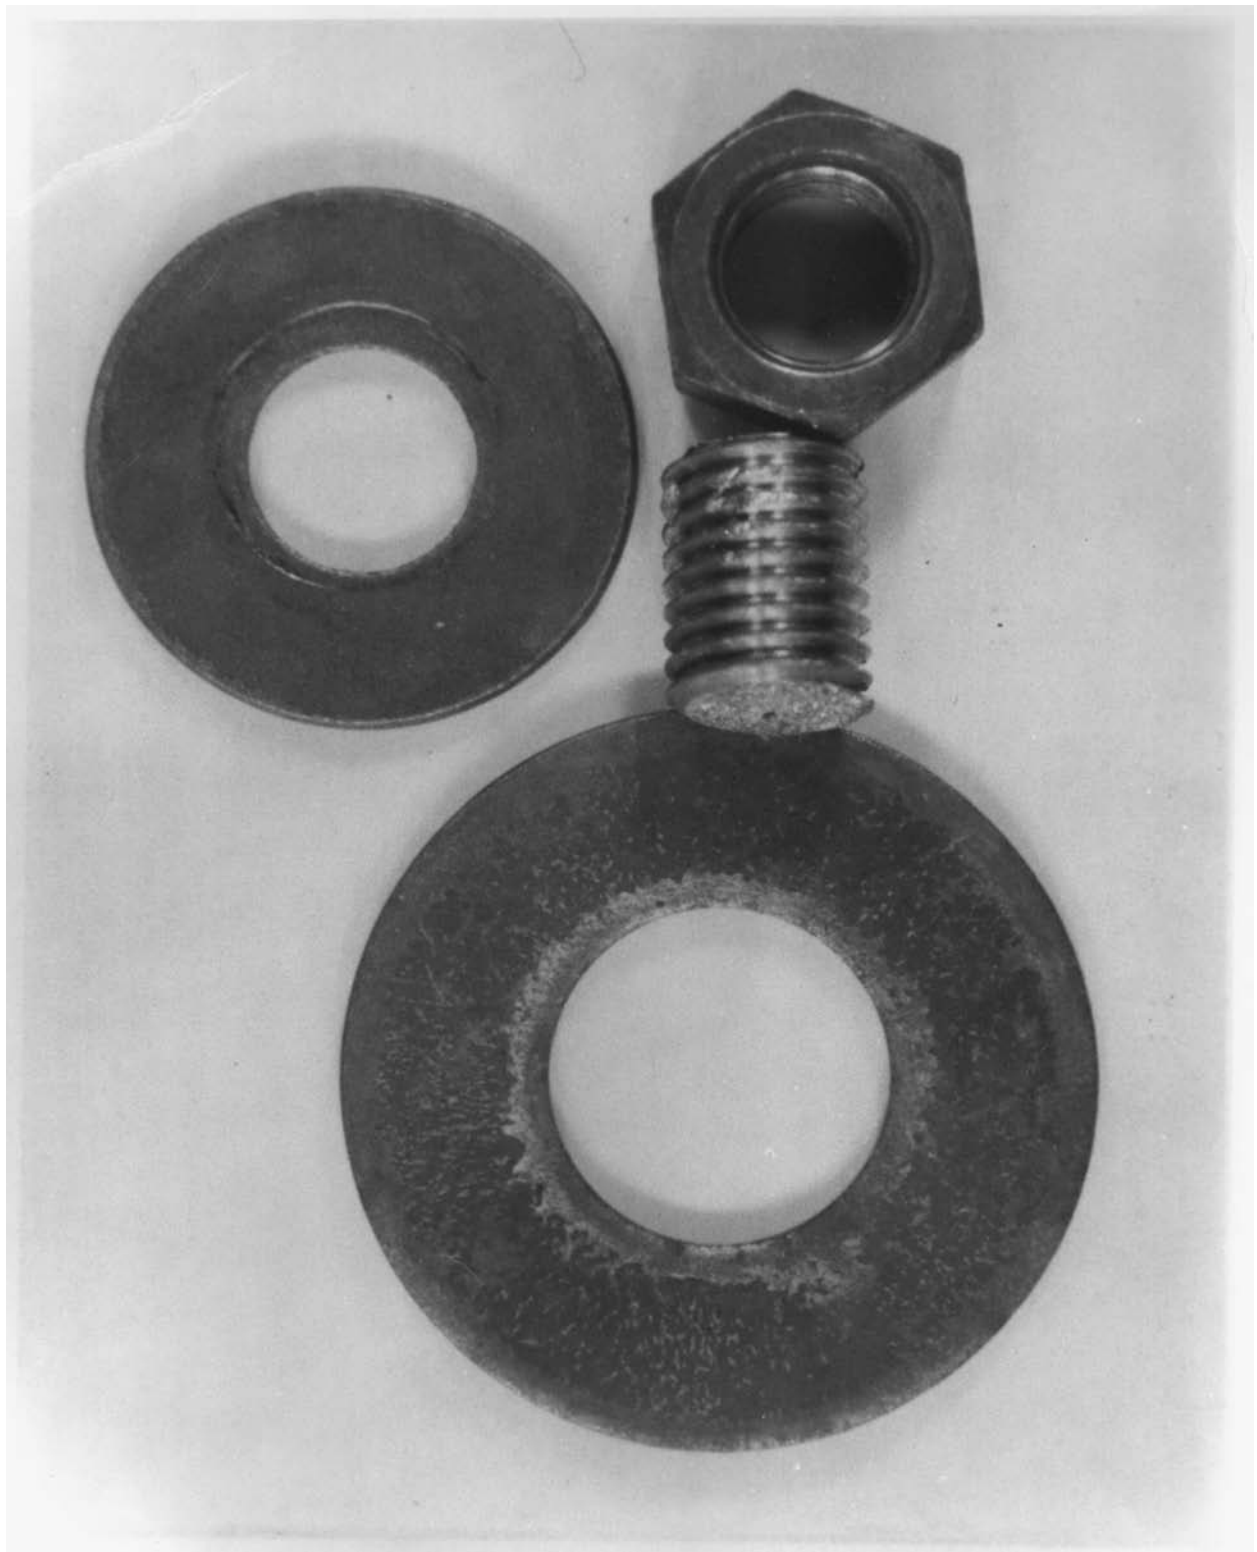
On June 19, 1980, in the company of a number of concerned people, I visited [redacted] High School. There I examined the part of a fractured eyebolt still extending from the ceiling of the gymnasium. On July 10, 1980, I again visited the school to witness the bolt being removed from the ceiling. A nut and two washers were removed from the bolt-segment, and an attempt was made to unscrew the segment with a pipe wrench. This attempt was abandoned, as the wrench was causing excessive damage to the threads. Finally, the bolt was sawed off close to the concrete beam it extended from, giving an approximate 1" length of the 3/4" bolt for study. The fracture surface was almost entirely undisturbed by the removal operations. A similar bolt was screwed out of the ceiling for study and comparison with the fractured bolt segment. The bolt segment and whole bolt and the associated hardware are shown in Figures 1 and 2.

Figure 1: End of fractured eyebolt and associated hardware.

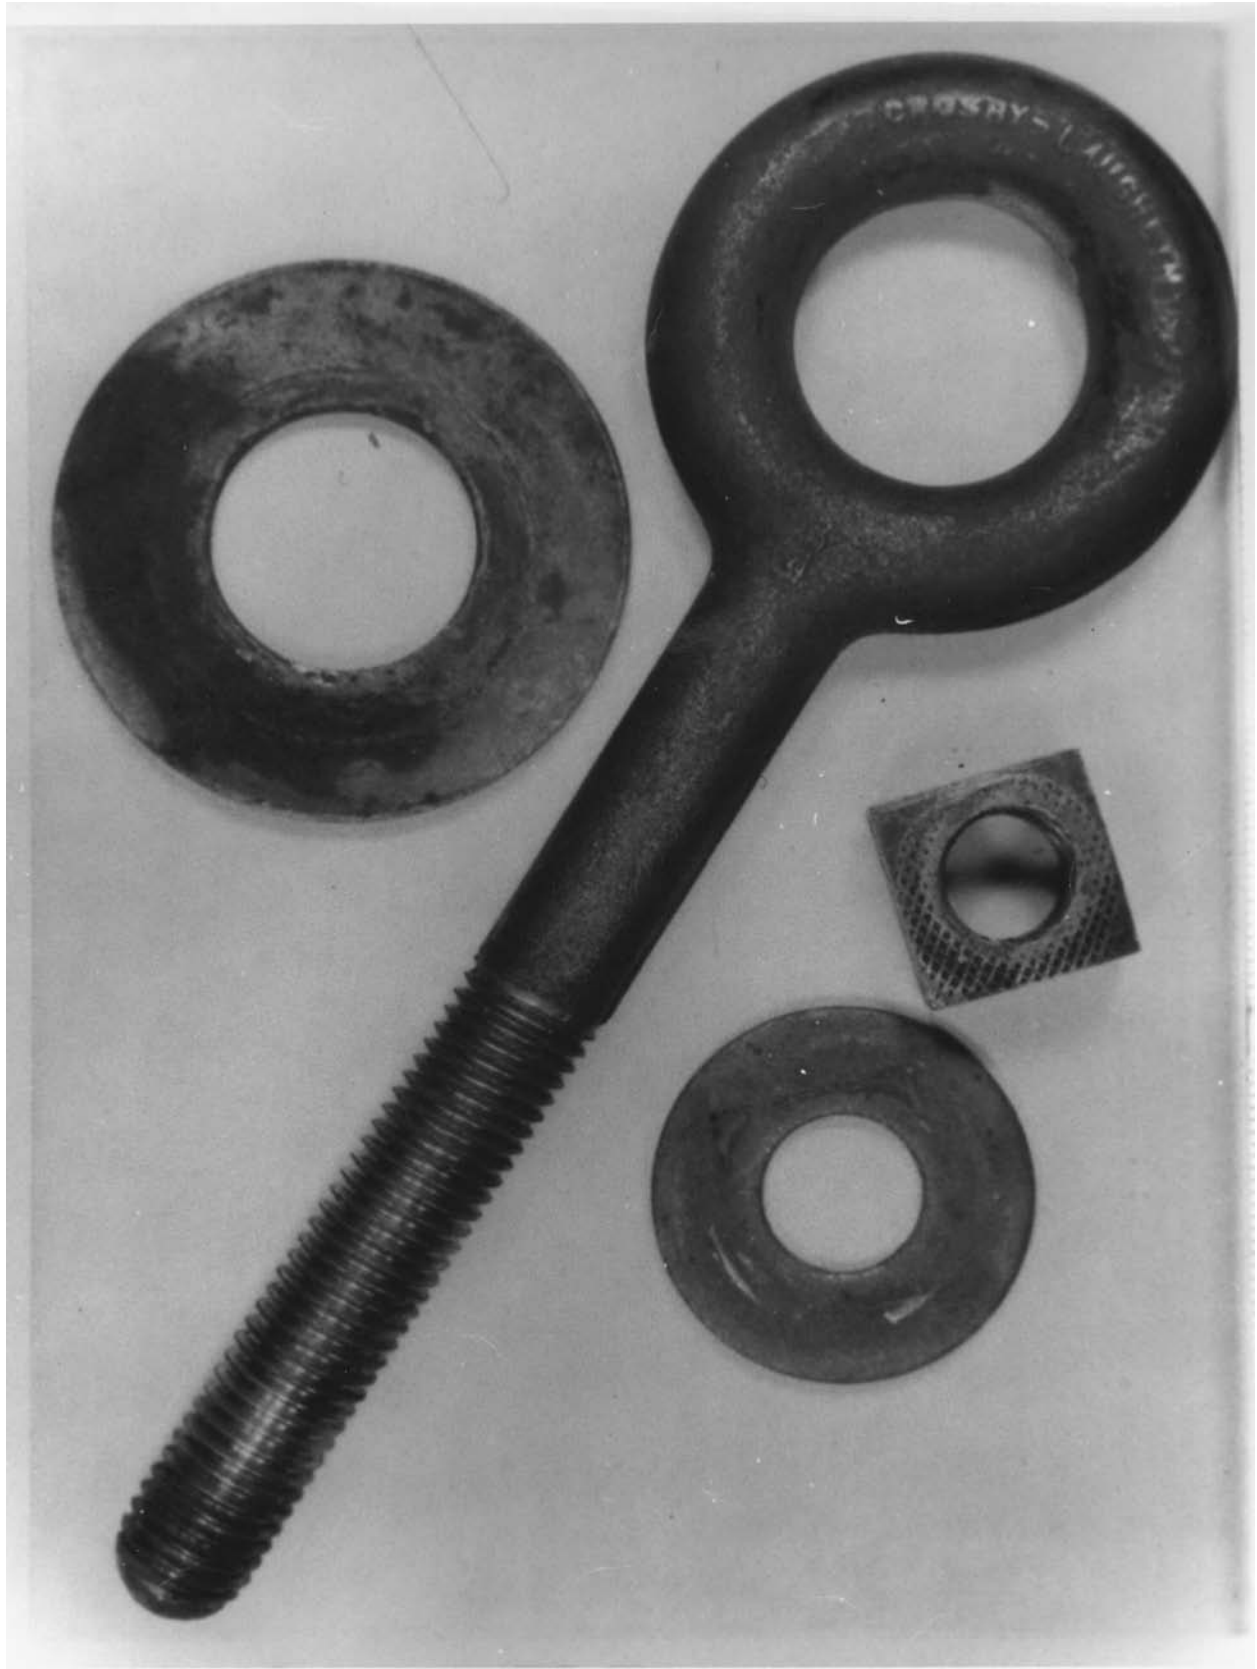
The second question concerns whether a bolt of the composition, manufacture, and design of that in Figure 2 is suitable for the use it received in the gym roof. The answer is clearly no. The problem is

Figure 2: Whole bolt and associated hardware.

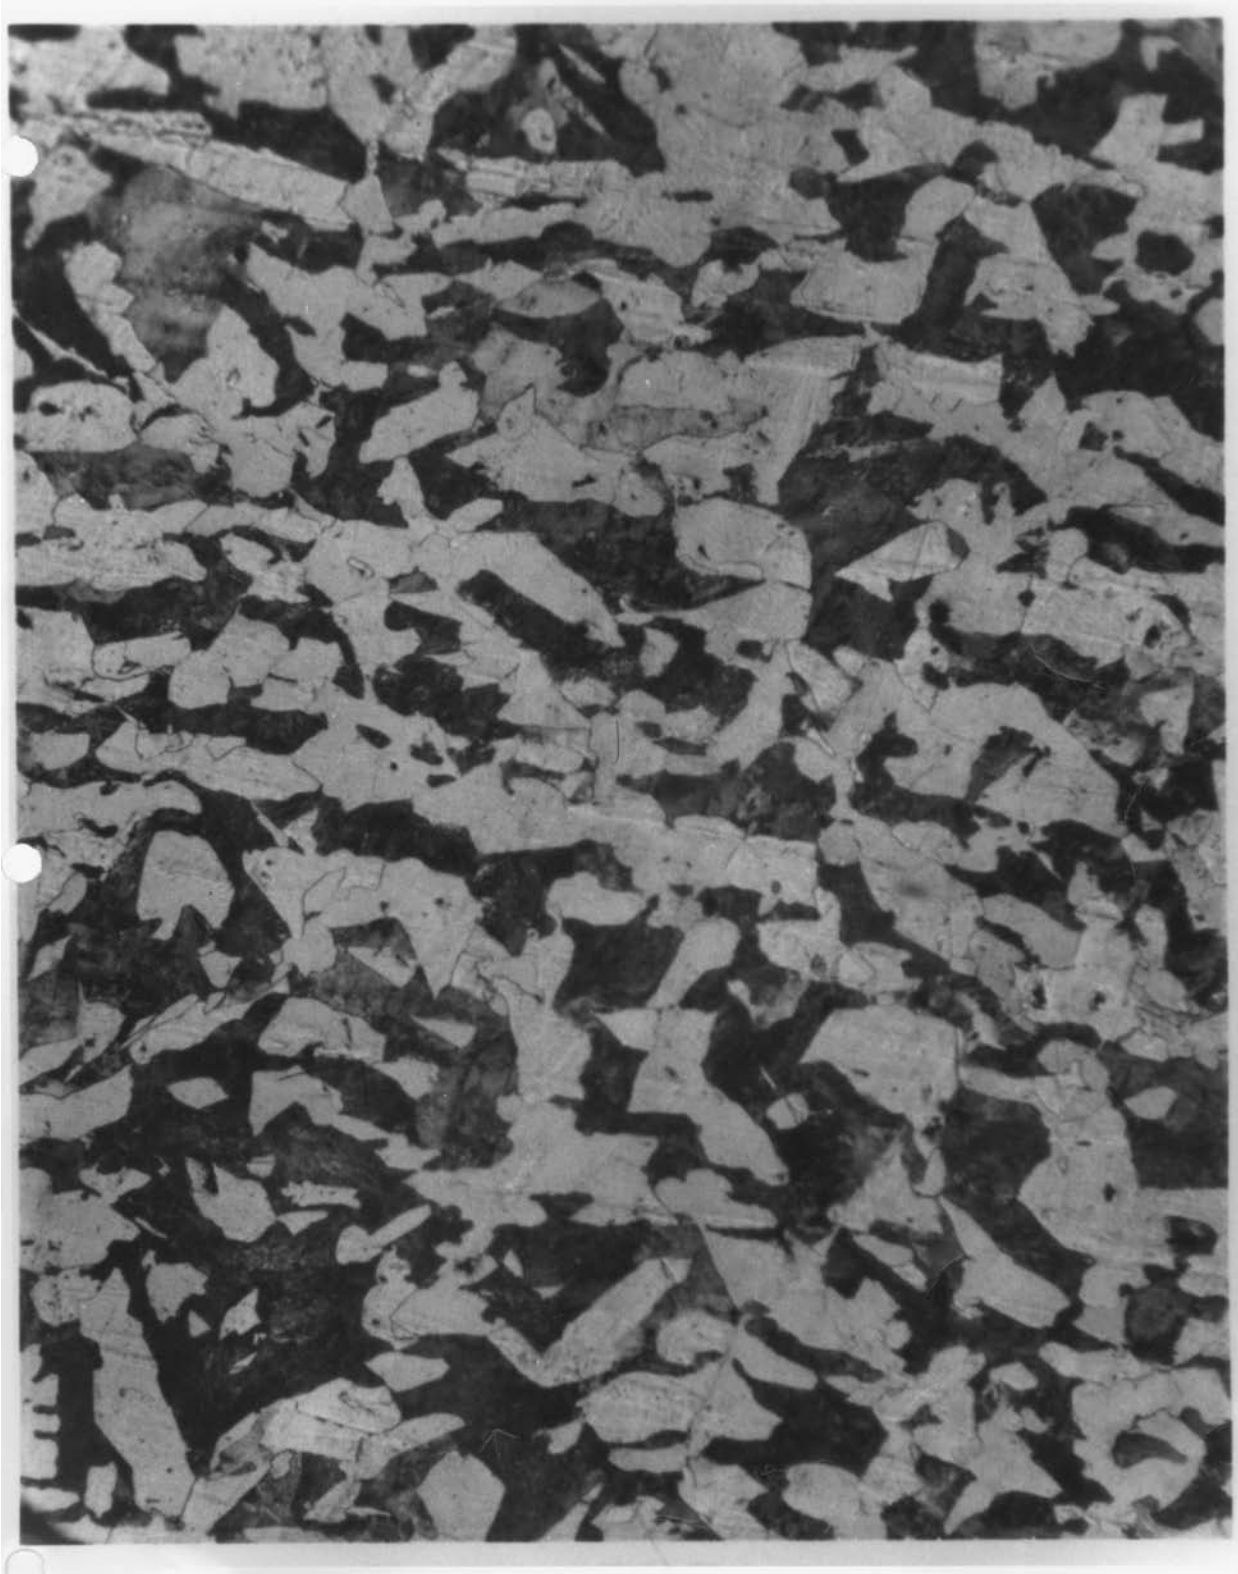
Figures 4 and 5 show the microstructures of the two bolts. Both bolts show the ferrite-pearlitic microstructures characteristic of steels of their composition. The two photomicrographs show no evidence of excessive porosity or other casting defects.

Figure 4: Microstructure of fracture bolt. (Transverse view, 200X)

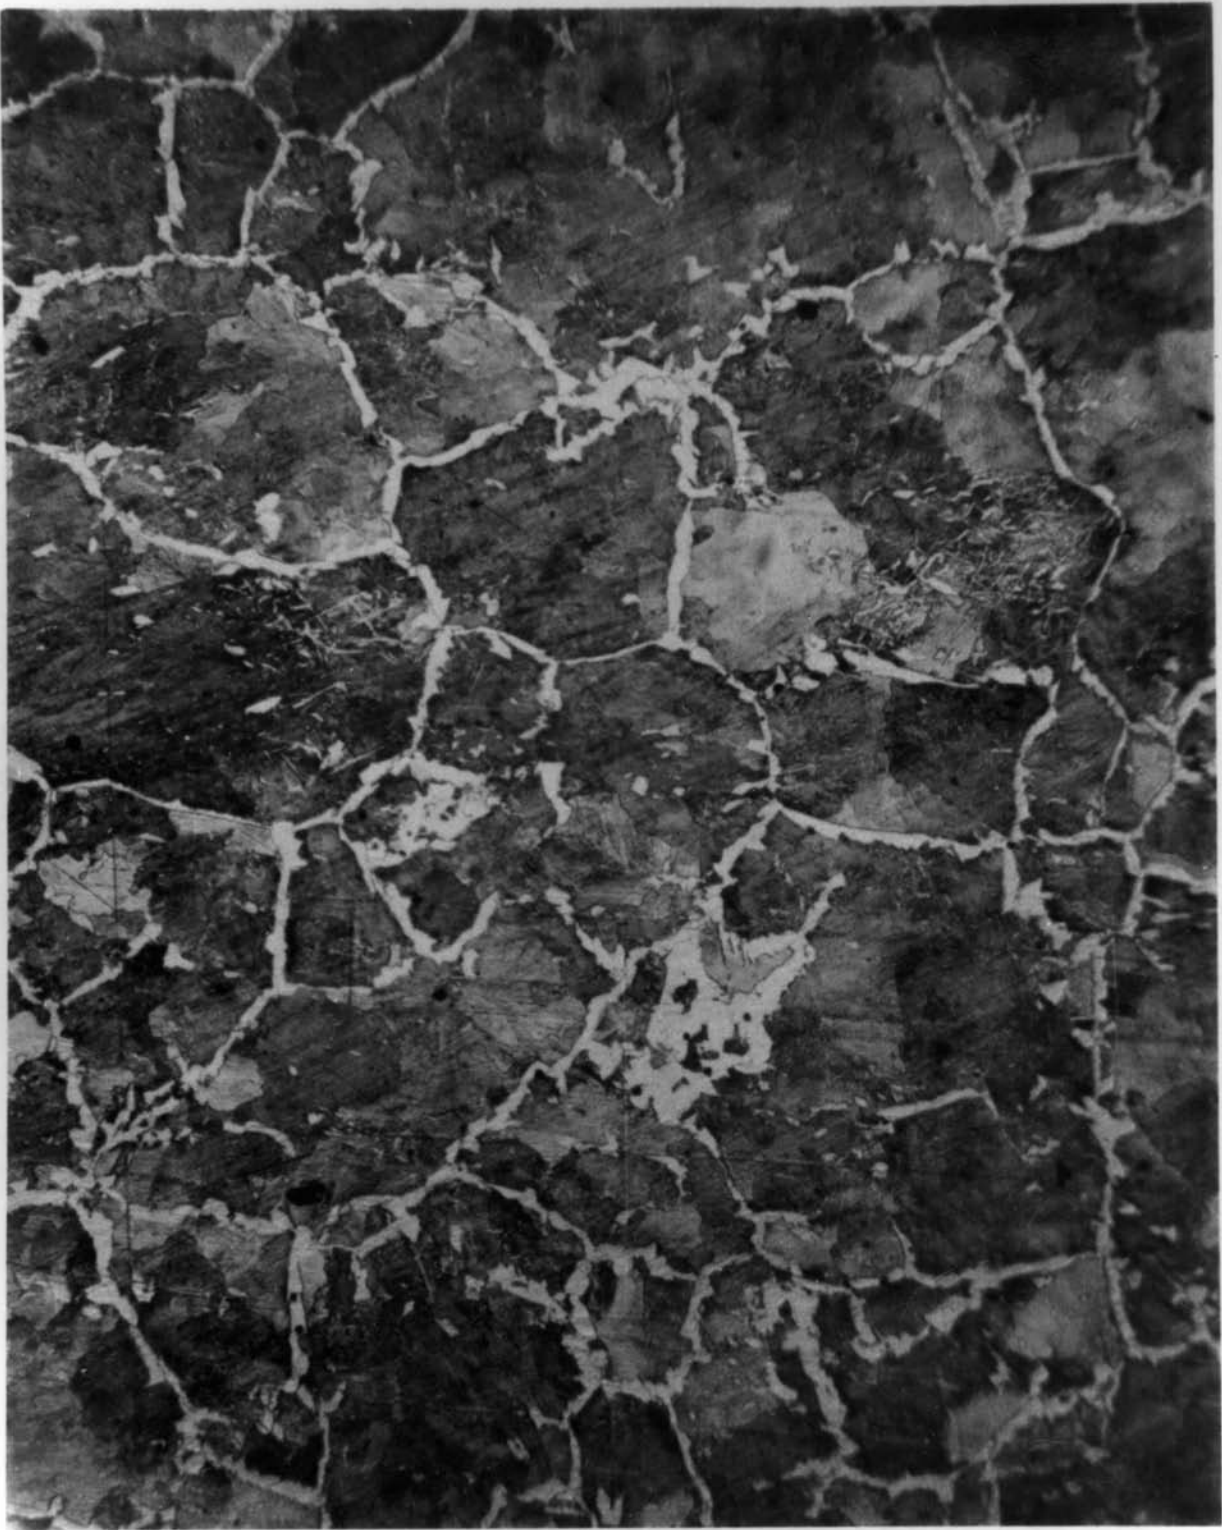
Figure 5: Microstructure of whole bolt. (100X)

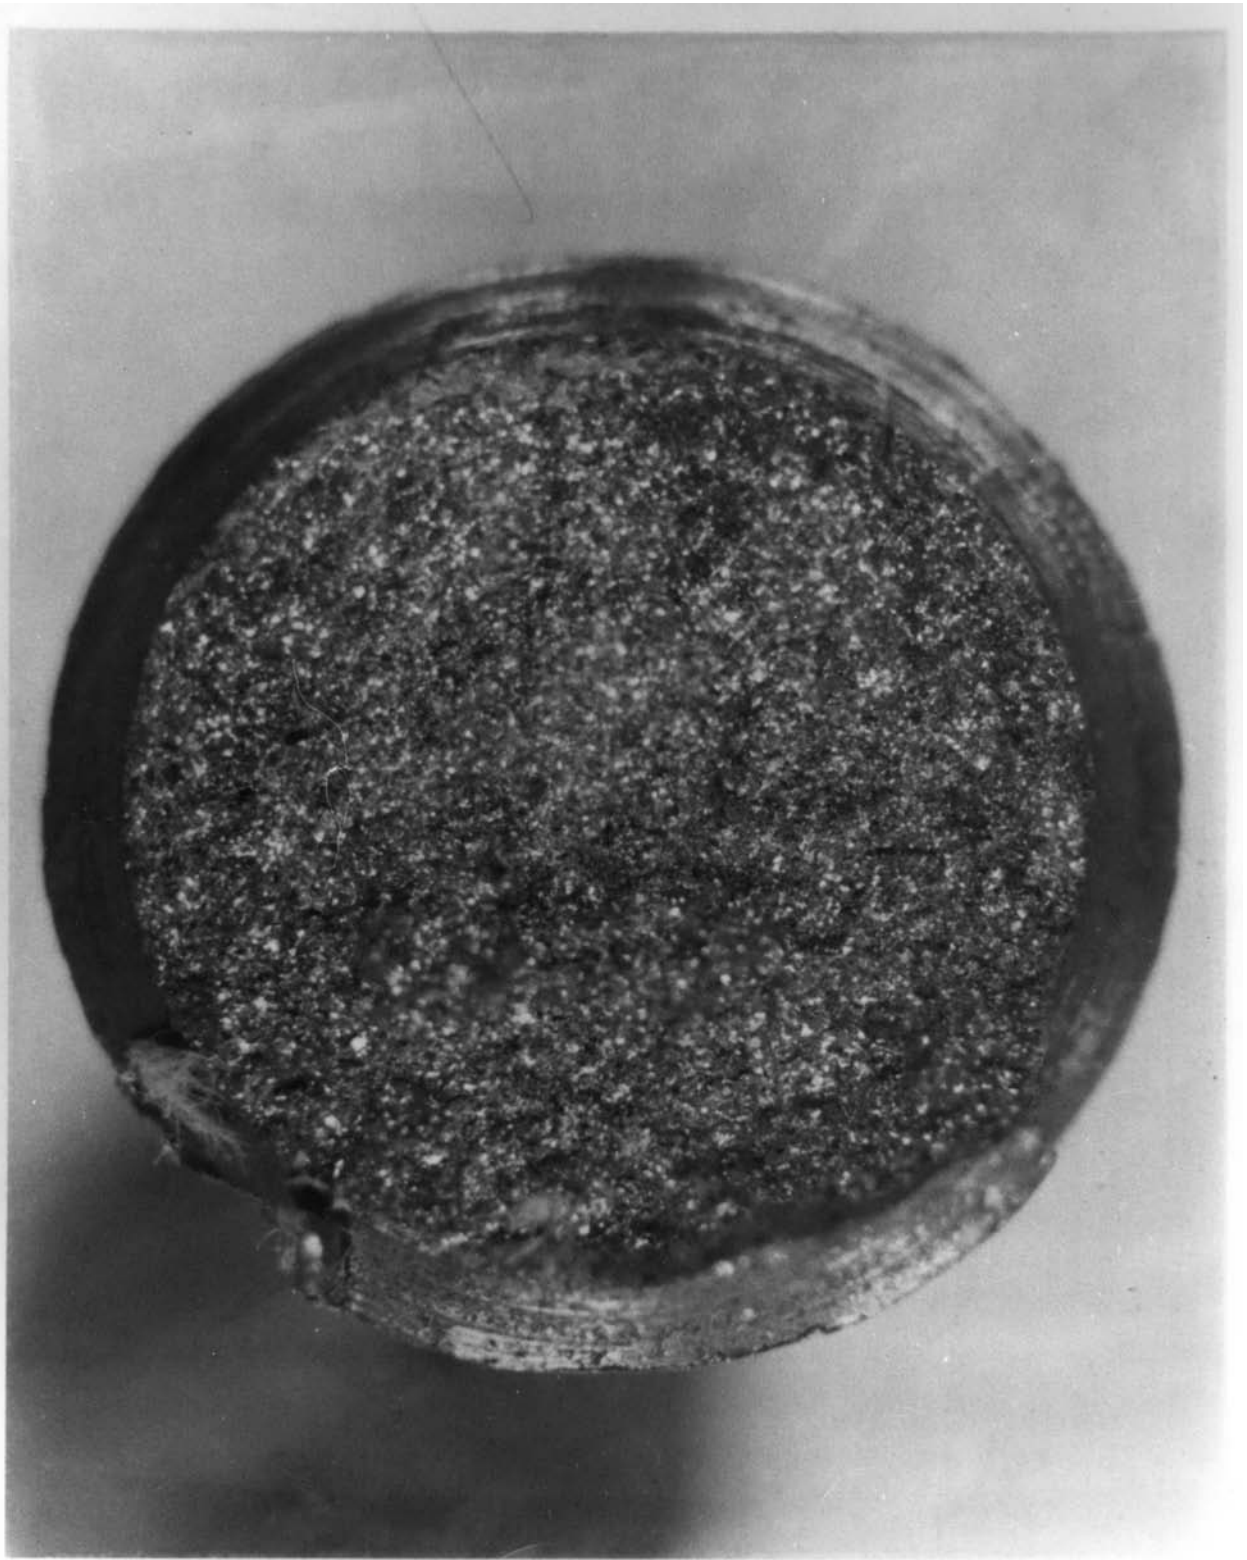
Figure 6 is an overall view of the fracture surface of the failed bolt. The surface appears to have tiny facets, which are characteristic of a brittle fracture.

Figure 6: Overall view of fracture surface of failed bolt.

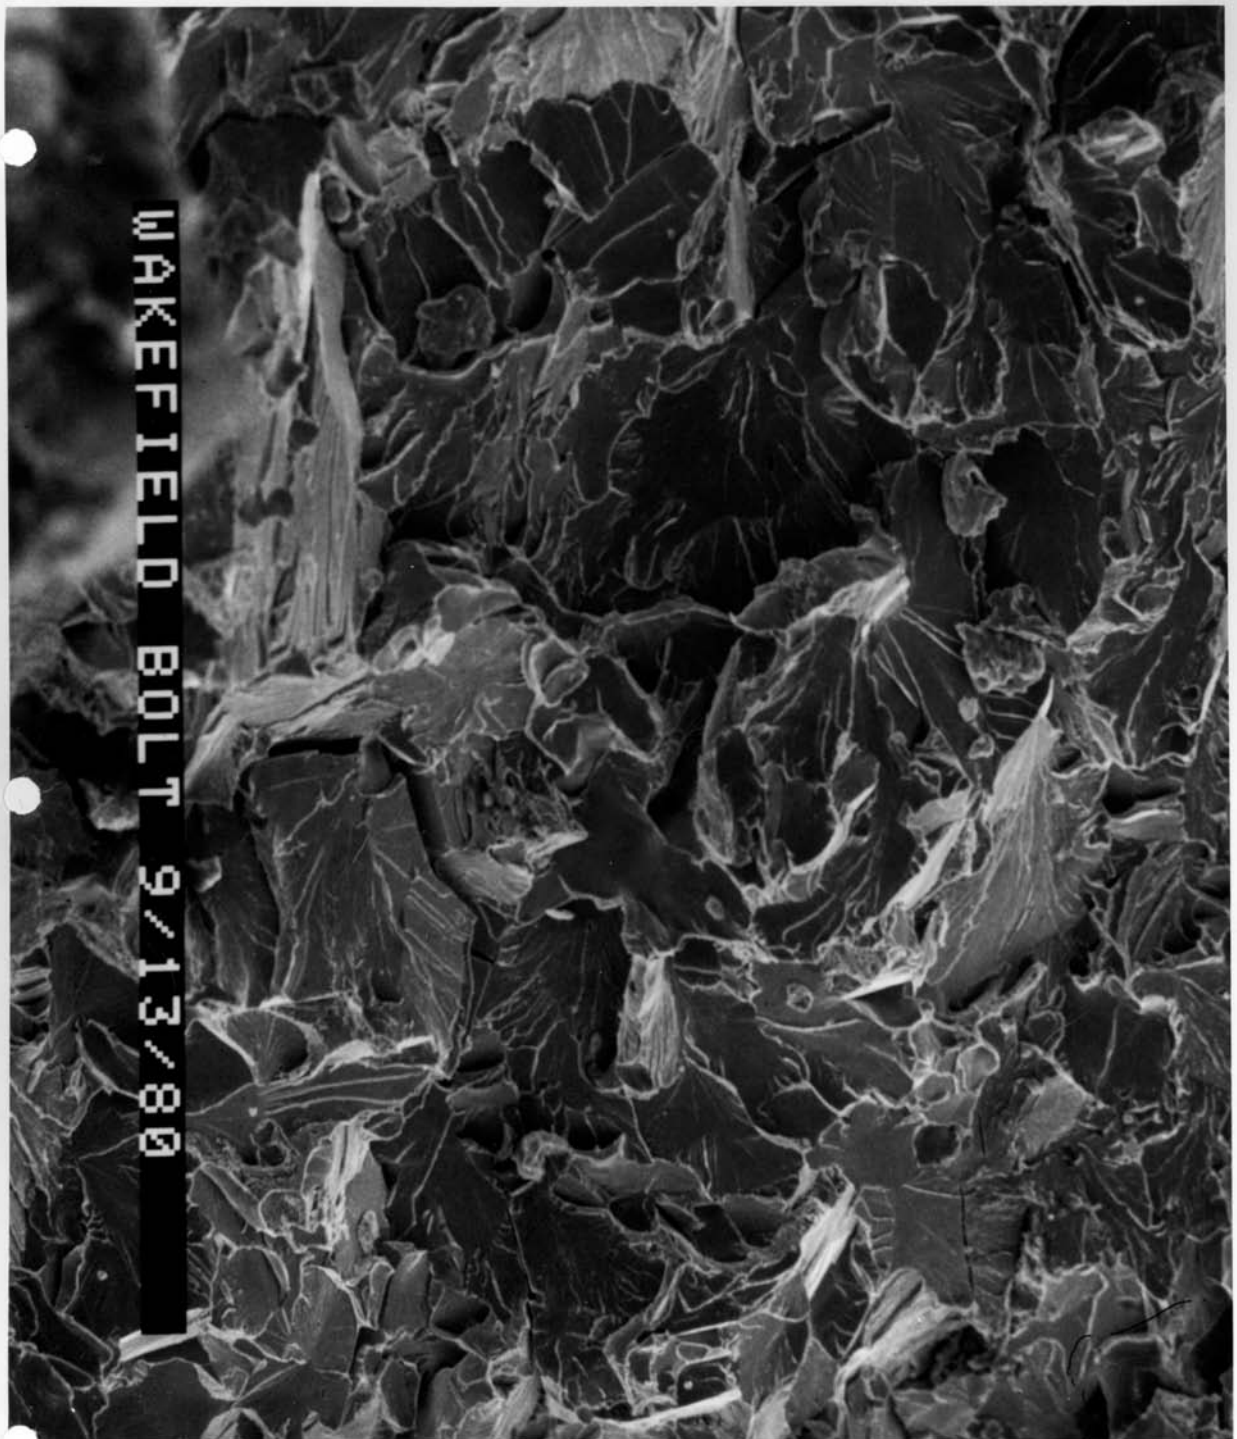
Figure 7 is a scanning electron micrograph of a typical region of the fracture surface. The fracture here and over the rest of the surface is totally brittle, with no signs of ductility. No fatigue striations were found. Figure 8 is a scanning electron micrograph, showing a crack at a thread root on the failed bolt.

Figure 7: Scanning electron micrograph of typical region of fracture surface. (320X)

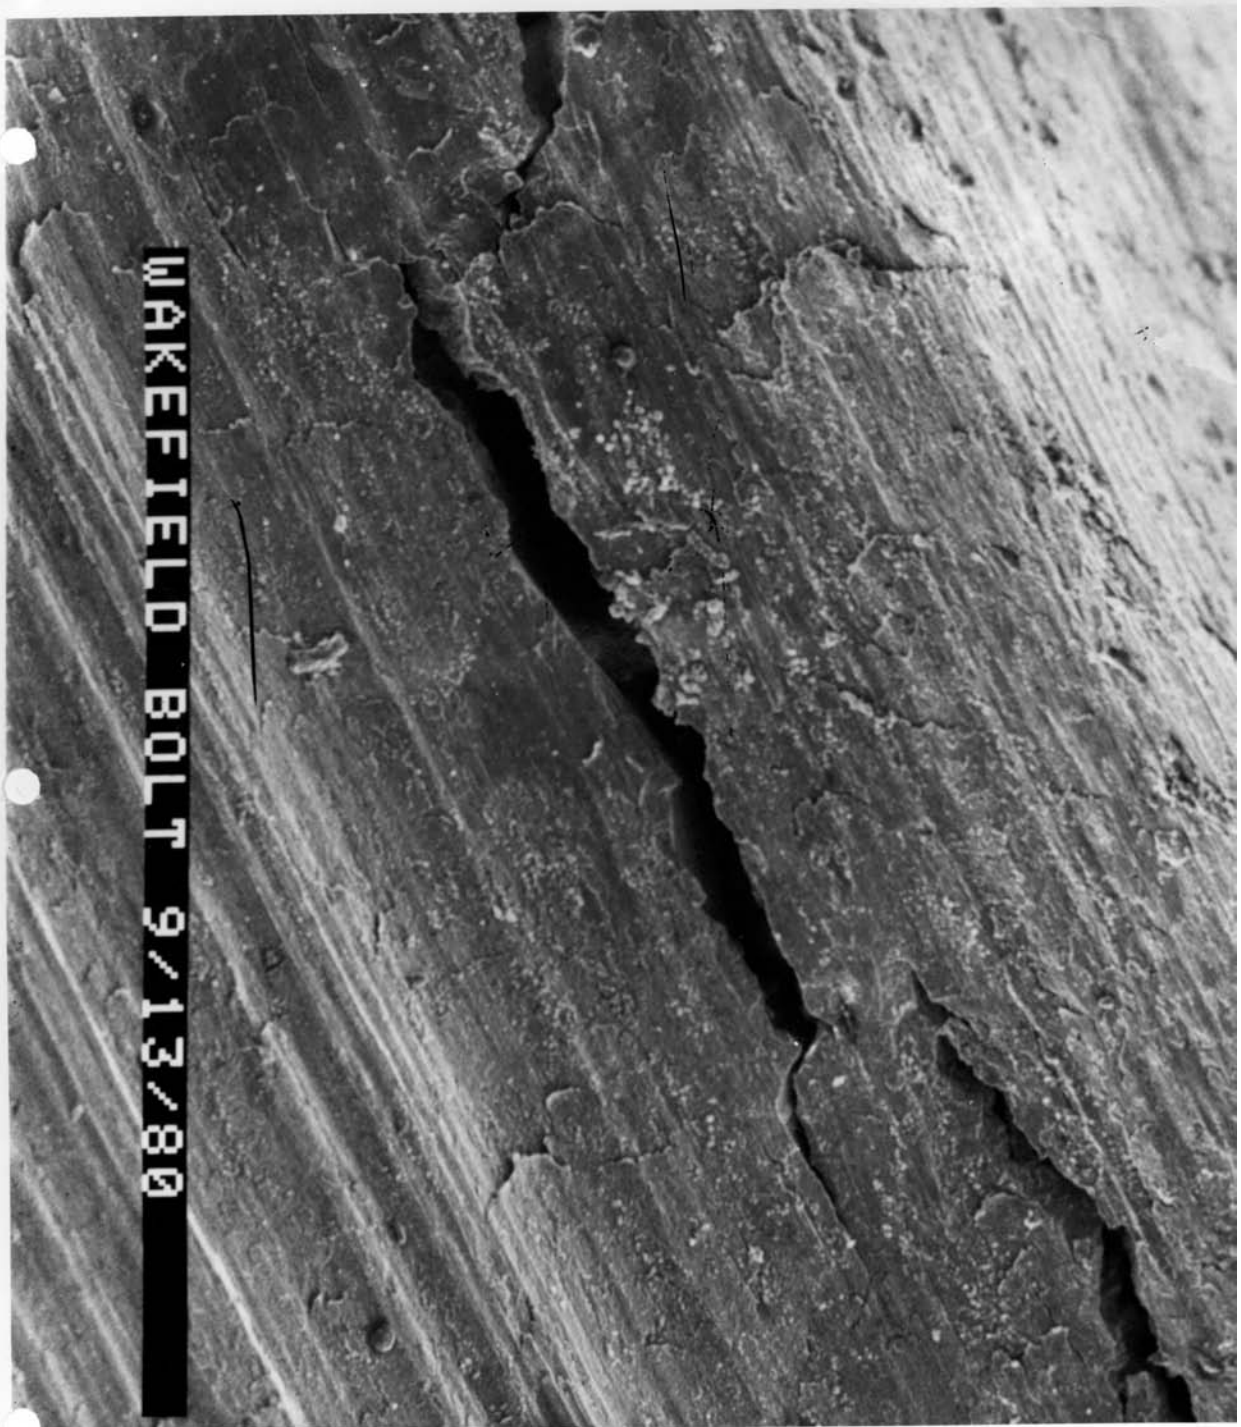
A number of similar cracks were observed in thread roots.

The one serious indication of defects in materials or workmanship is the thread-root cracking seen in Figure 8. Such cracks should not occur in a steel as ductile as the eyebolt is supposed to be. Such cracks will propagate during use and tend to give the brittle fracture observed. An un-cracked, un-notched sample will show the kind of ductile failure reported in Figure 9. There are several possible causes for this root cracking. First, it could have occurred during use in the gym. This seems unlikely, as the threads were inside the nut, and would have been largely protected from the bending stresses exerted by people swinging from the rope. The stresses exerted during removal could hardly cause the cracking, either. If the root cracks did not occur during use, they probably occurred during threading, either due to brittle material or improper machining. Steel castings are supposed to be given a stress-relieving anneal before being used. A casting which had not been given a proper anneal would tend to be brittle and crack more easily. Improper threading practice - such as the wrong speed or lubricant - could give high local heating or stresses and produce cracking.

Figure 8: Scanning electron micrograph showing cracks at thread roots in failed bolt. (200X)
