Operational Reactor Safety

Lecture 21

Davis Besse - Near Miss 2002

Davis Besse - 873 Mwe Babcock and Wilcox Design

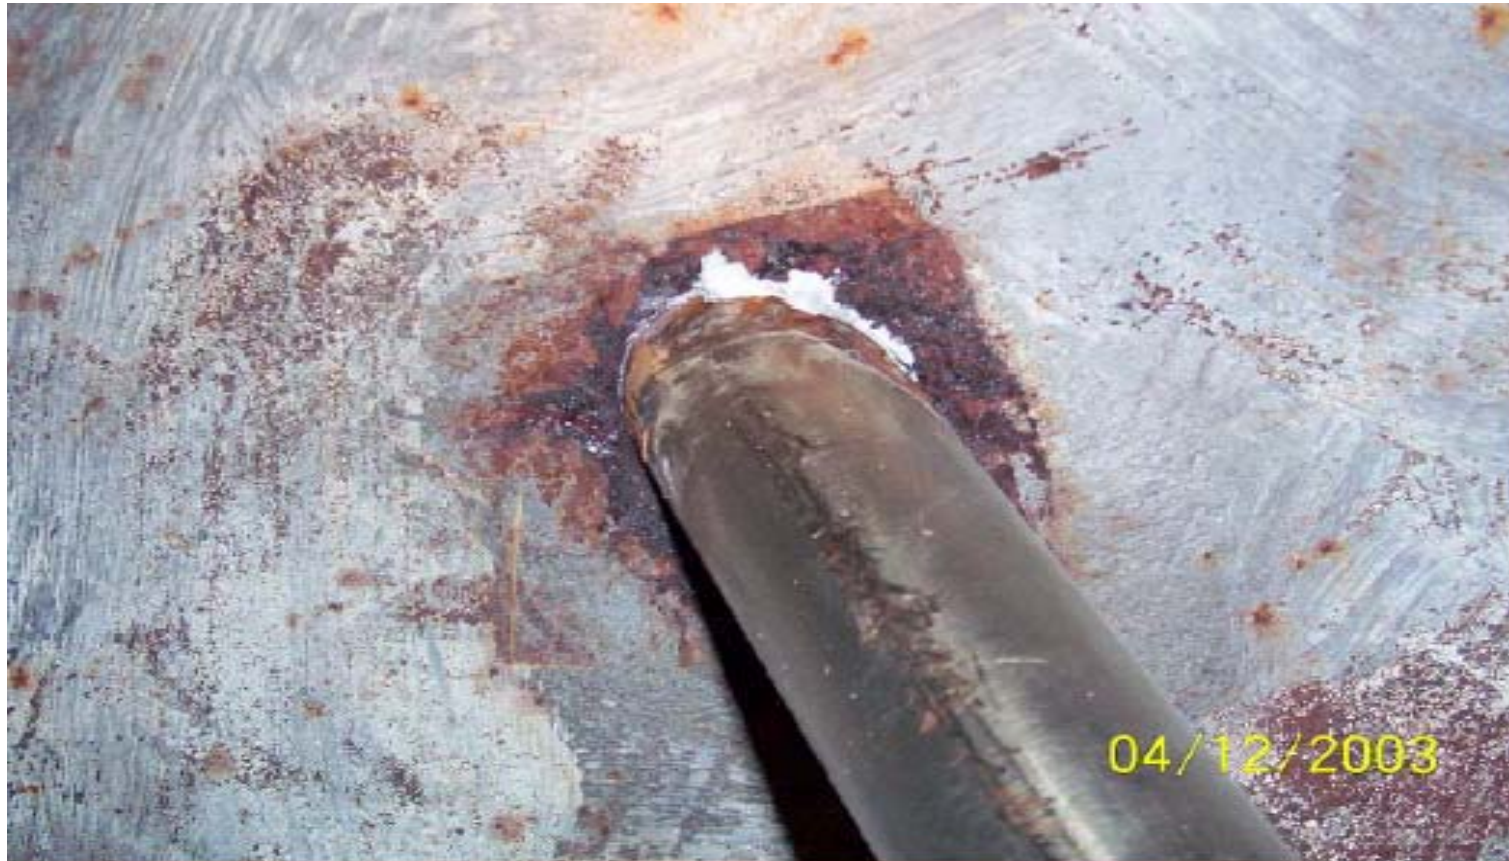
STP Penetration # 46

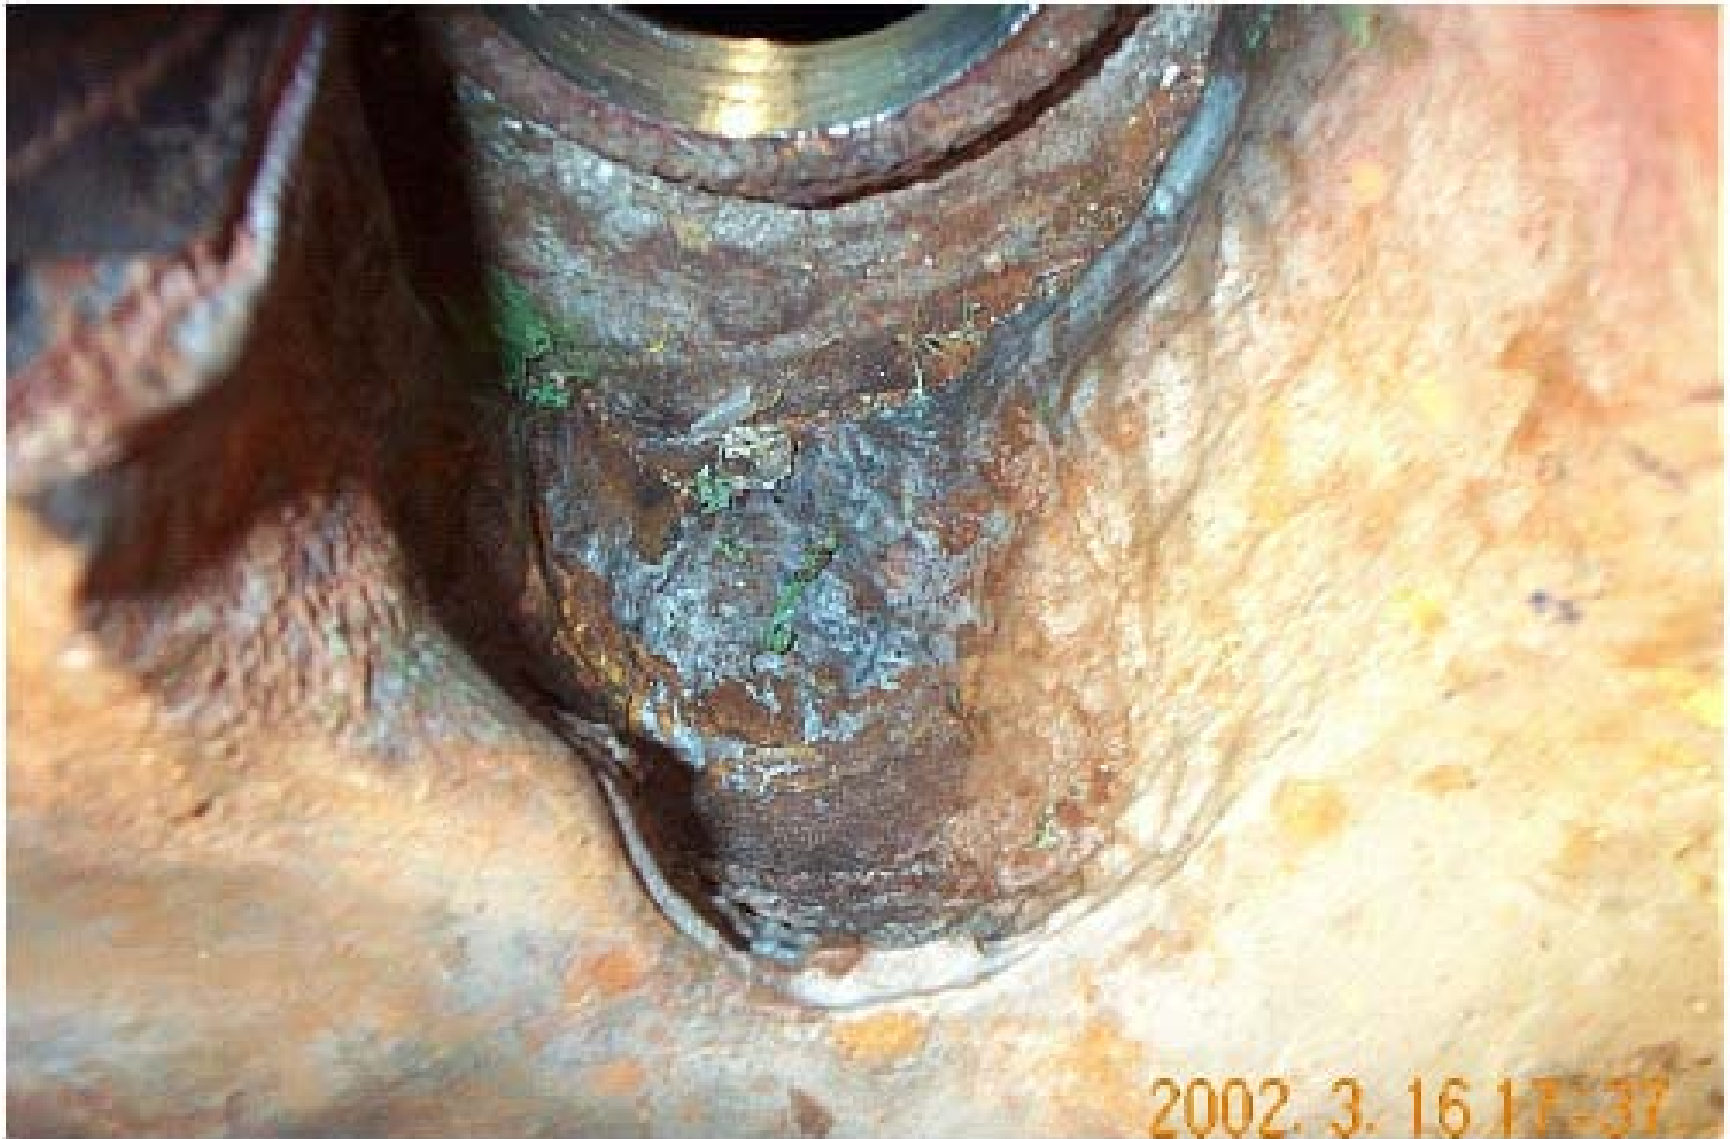
Nozzle 3 with insulation removed and shielding installed 03-16-02

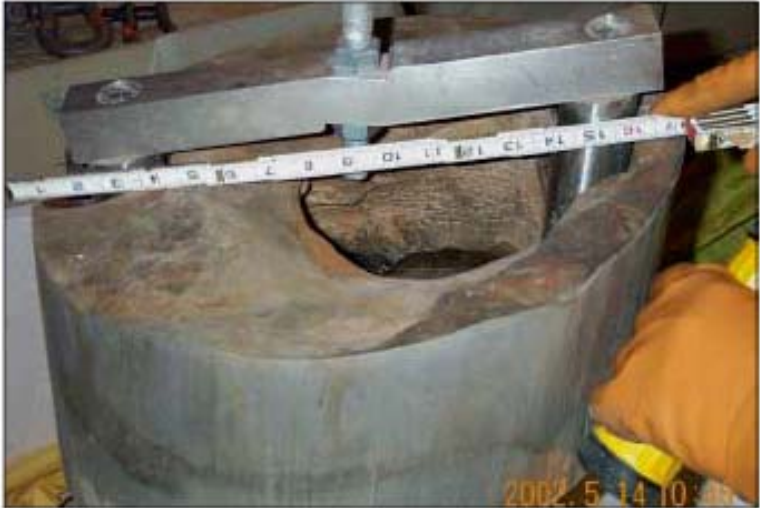
Degradation Between Nozzle#3 and Nozzle#11.
The Sketch Provided by the Licensee

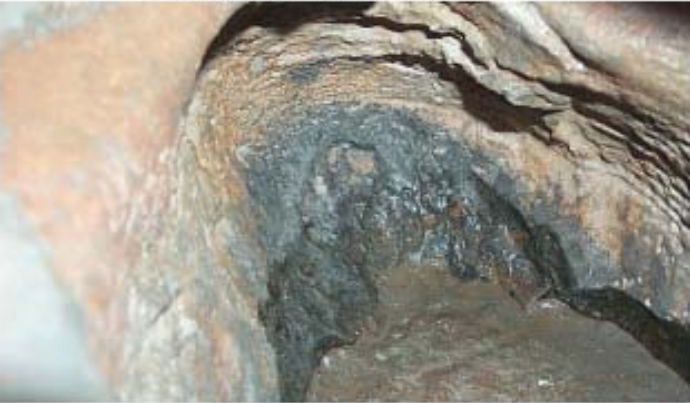
Nozzle #3 Area Cut Away From Reactor Head

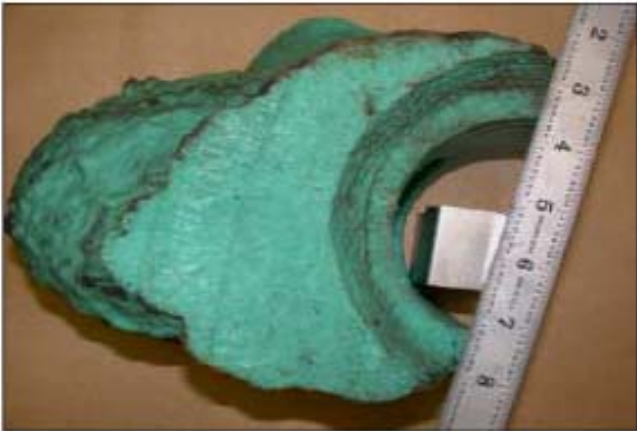
Close-Up View of Cavity

Rubberized Impression of Cavity

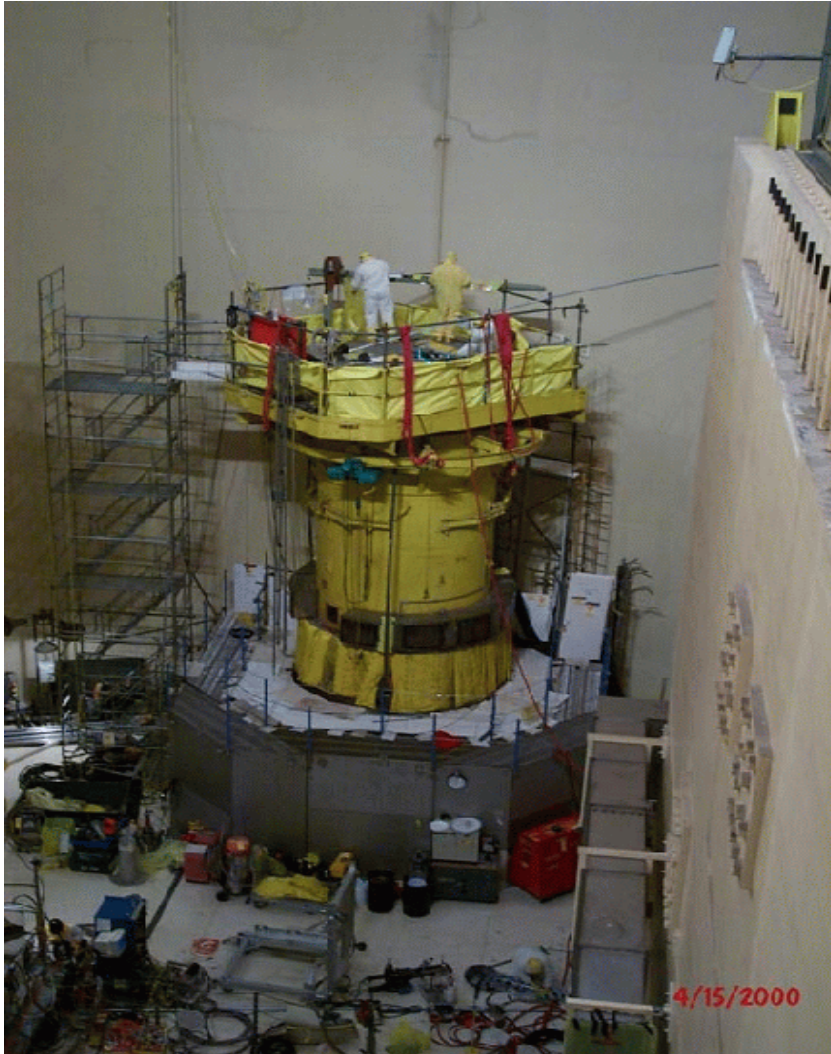
Davis-Besse Reactor Vessel

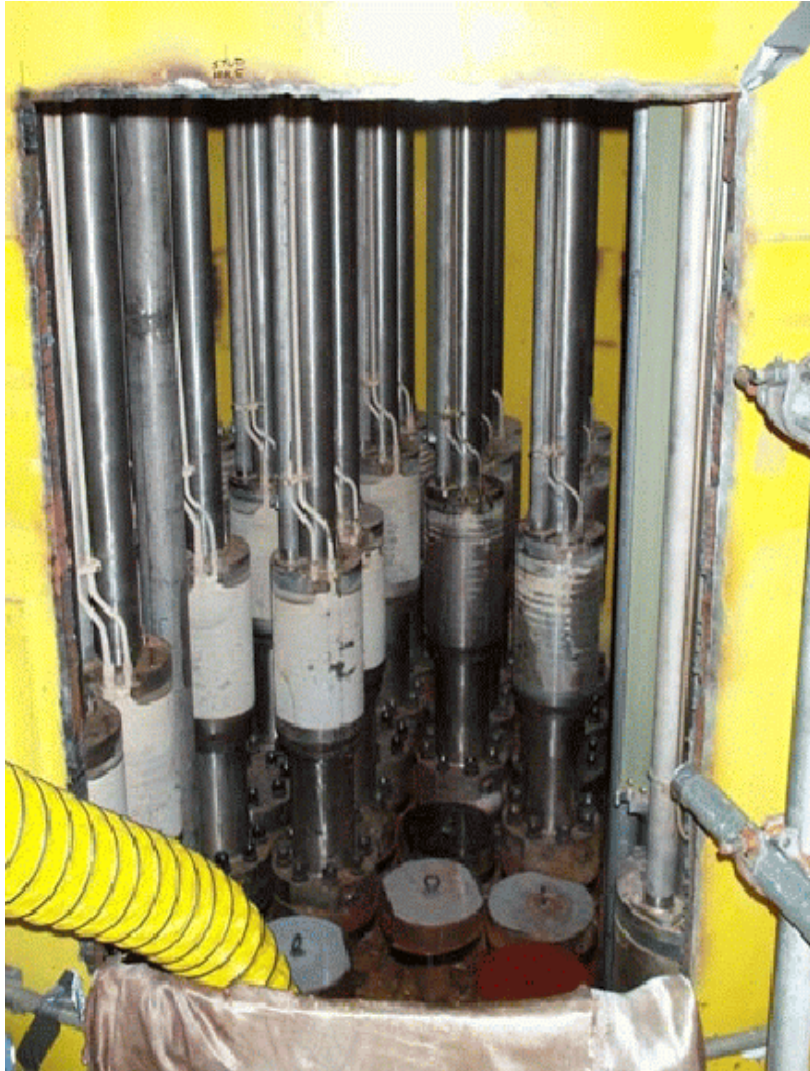
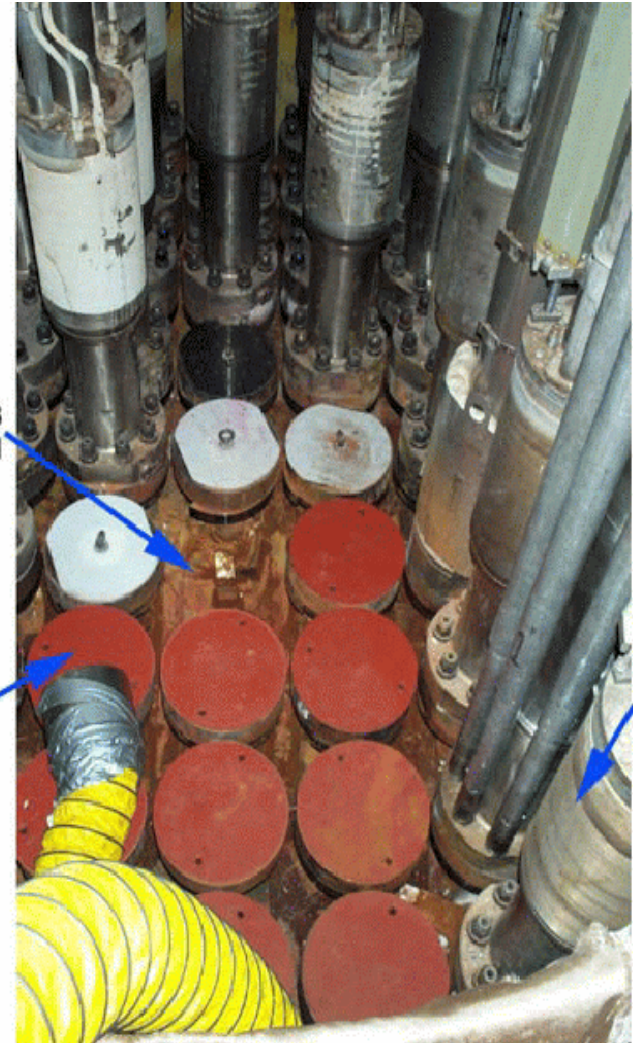
Control Rod Drive Mechanisms

Nozzle #3
Removed

Reactor
Vessel
Head
Nozzle
to CRDM
Flange

Control
Rod Drive
Mechanism
Still Bolted
to Nozzle

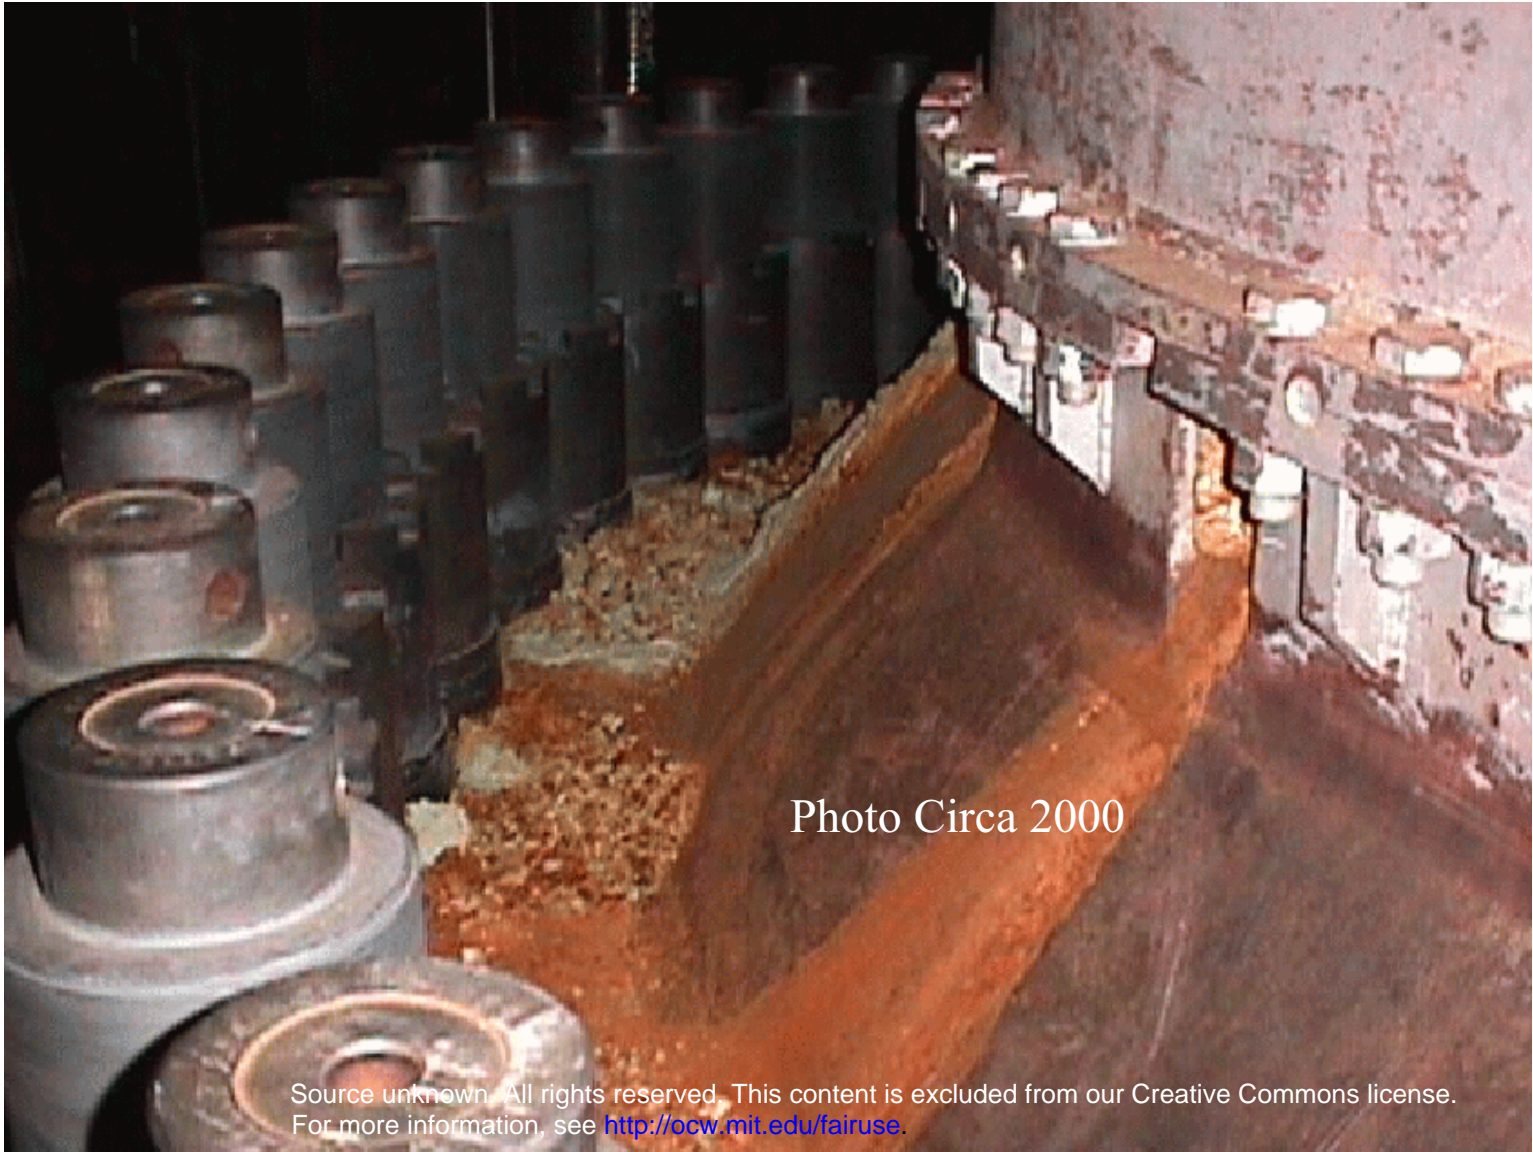
Missed Opportunities

Photo Circa 2000
